## HAMPDEN COUNTY REGISTRY OF DEEDS

### DAMS FILE COLLECTION

### BOOK D25 – 3 (L-T)

Reports Section – Dams - Hampden County Massachusetts

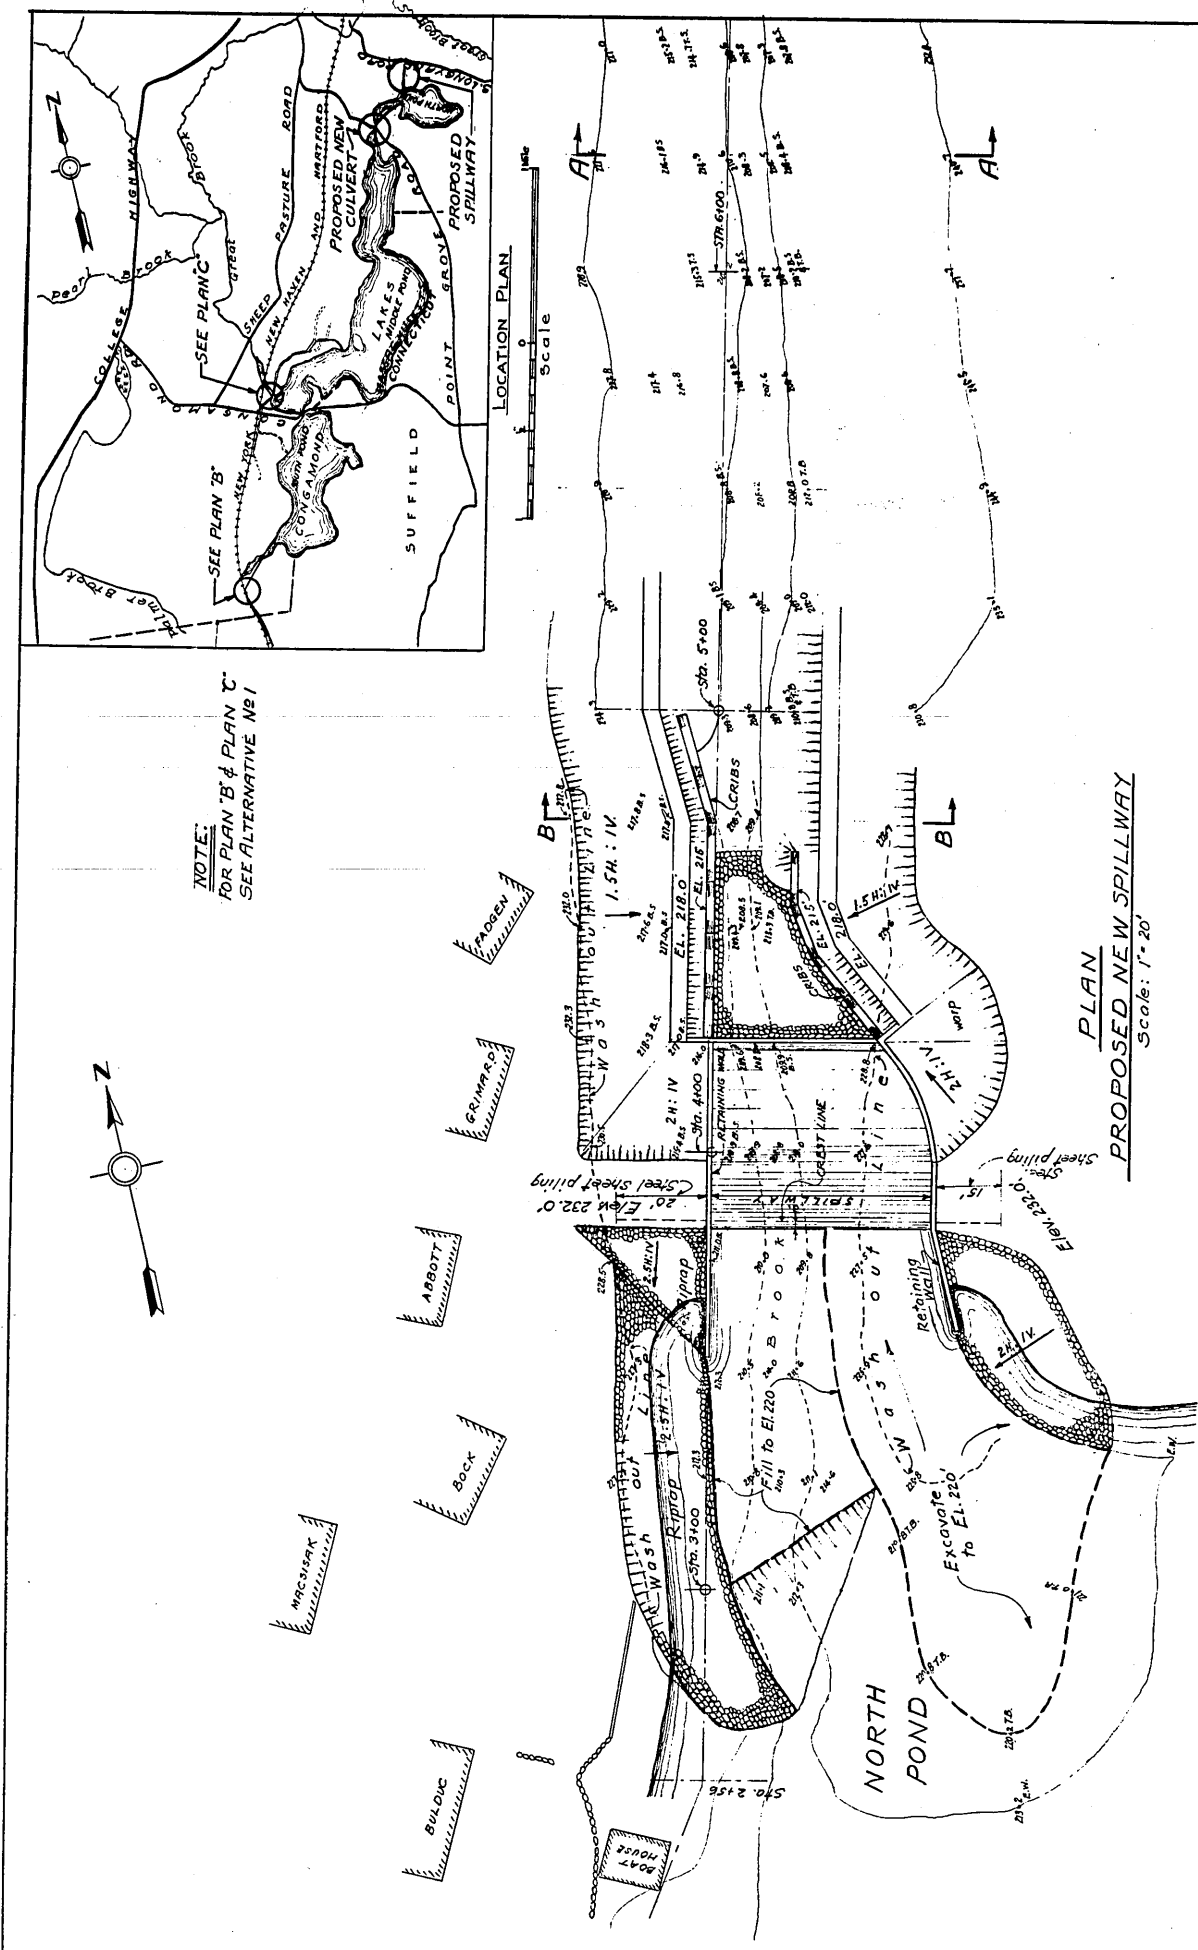
PLAN  
PROPOSED NEW SPILLWAY  
Scale: 1"=20'

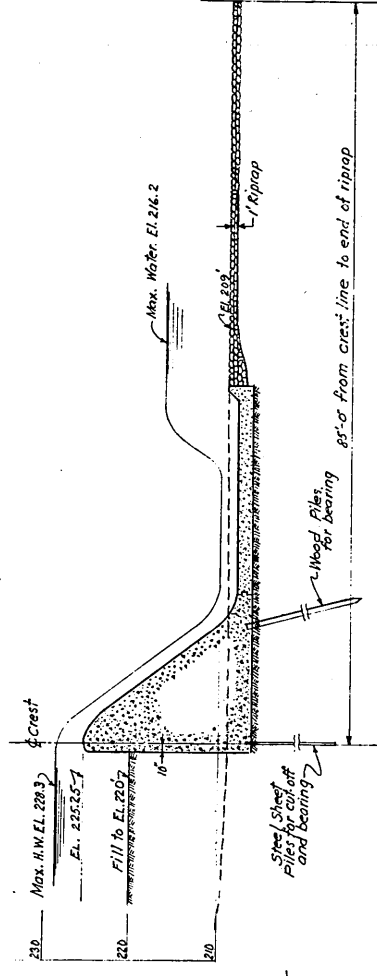
TYPICAL SECTION THRU DAM  
Scale: 1"=10'

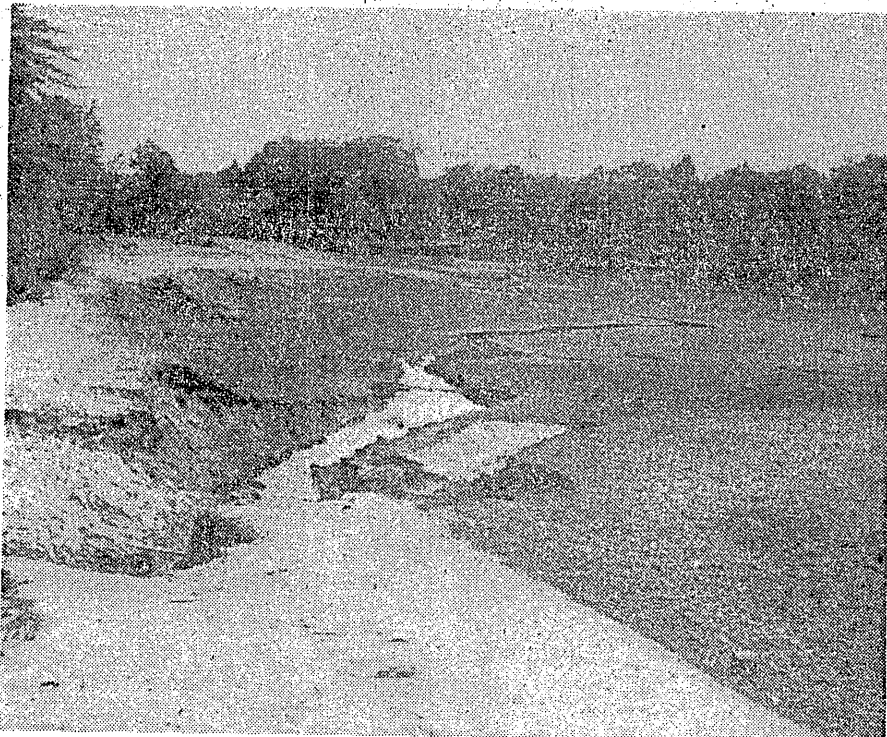
A new picture of the dry bed of North Pond at Congamond Lakes created as some of the damage of the Aug., 1955, floods. It will shortly be transformed to the beautiful pond it has always been, according to plans now in possession of the Hampden County Commission. By the erection of an earthen plug at the drainage point off the bottom of the picture, the Division of Waterways of the State Department of Public Works expects to restore the level of the pond and also restore the numerous summer camps and permanent homes to their previous value.

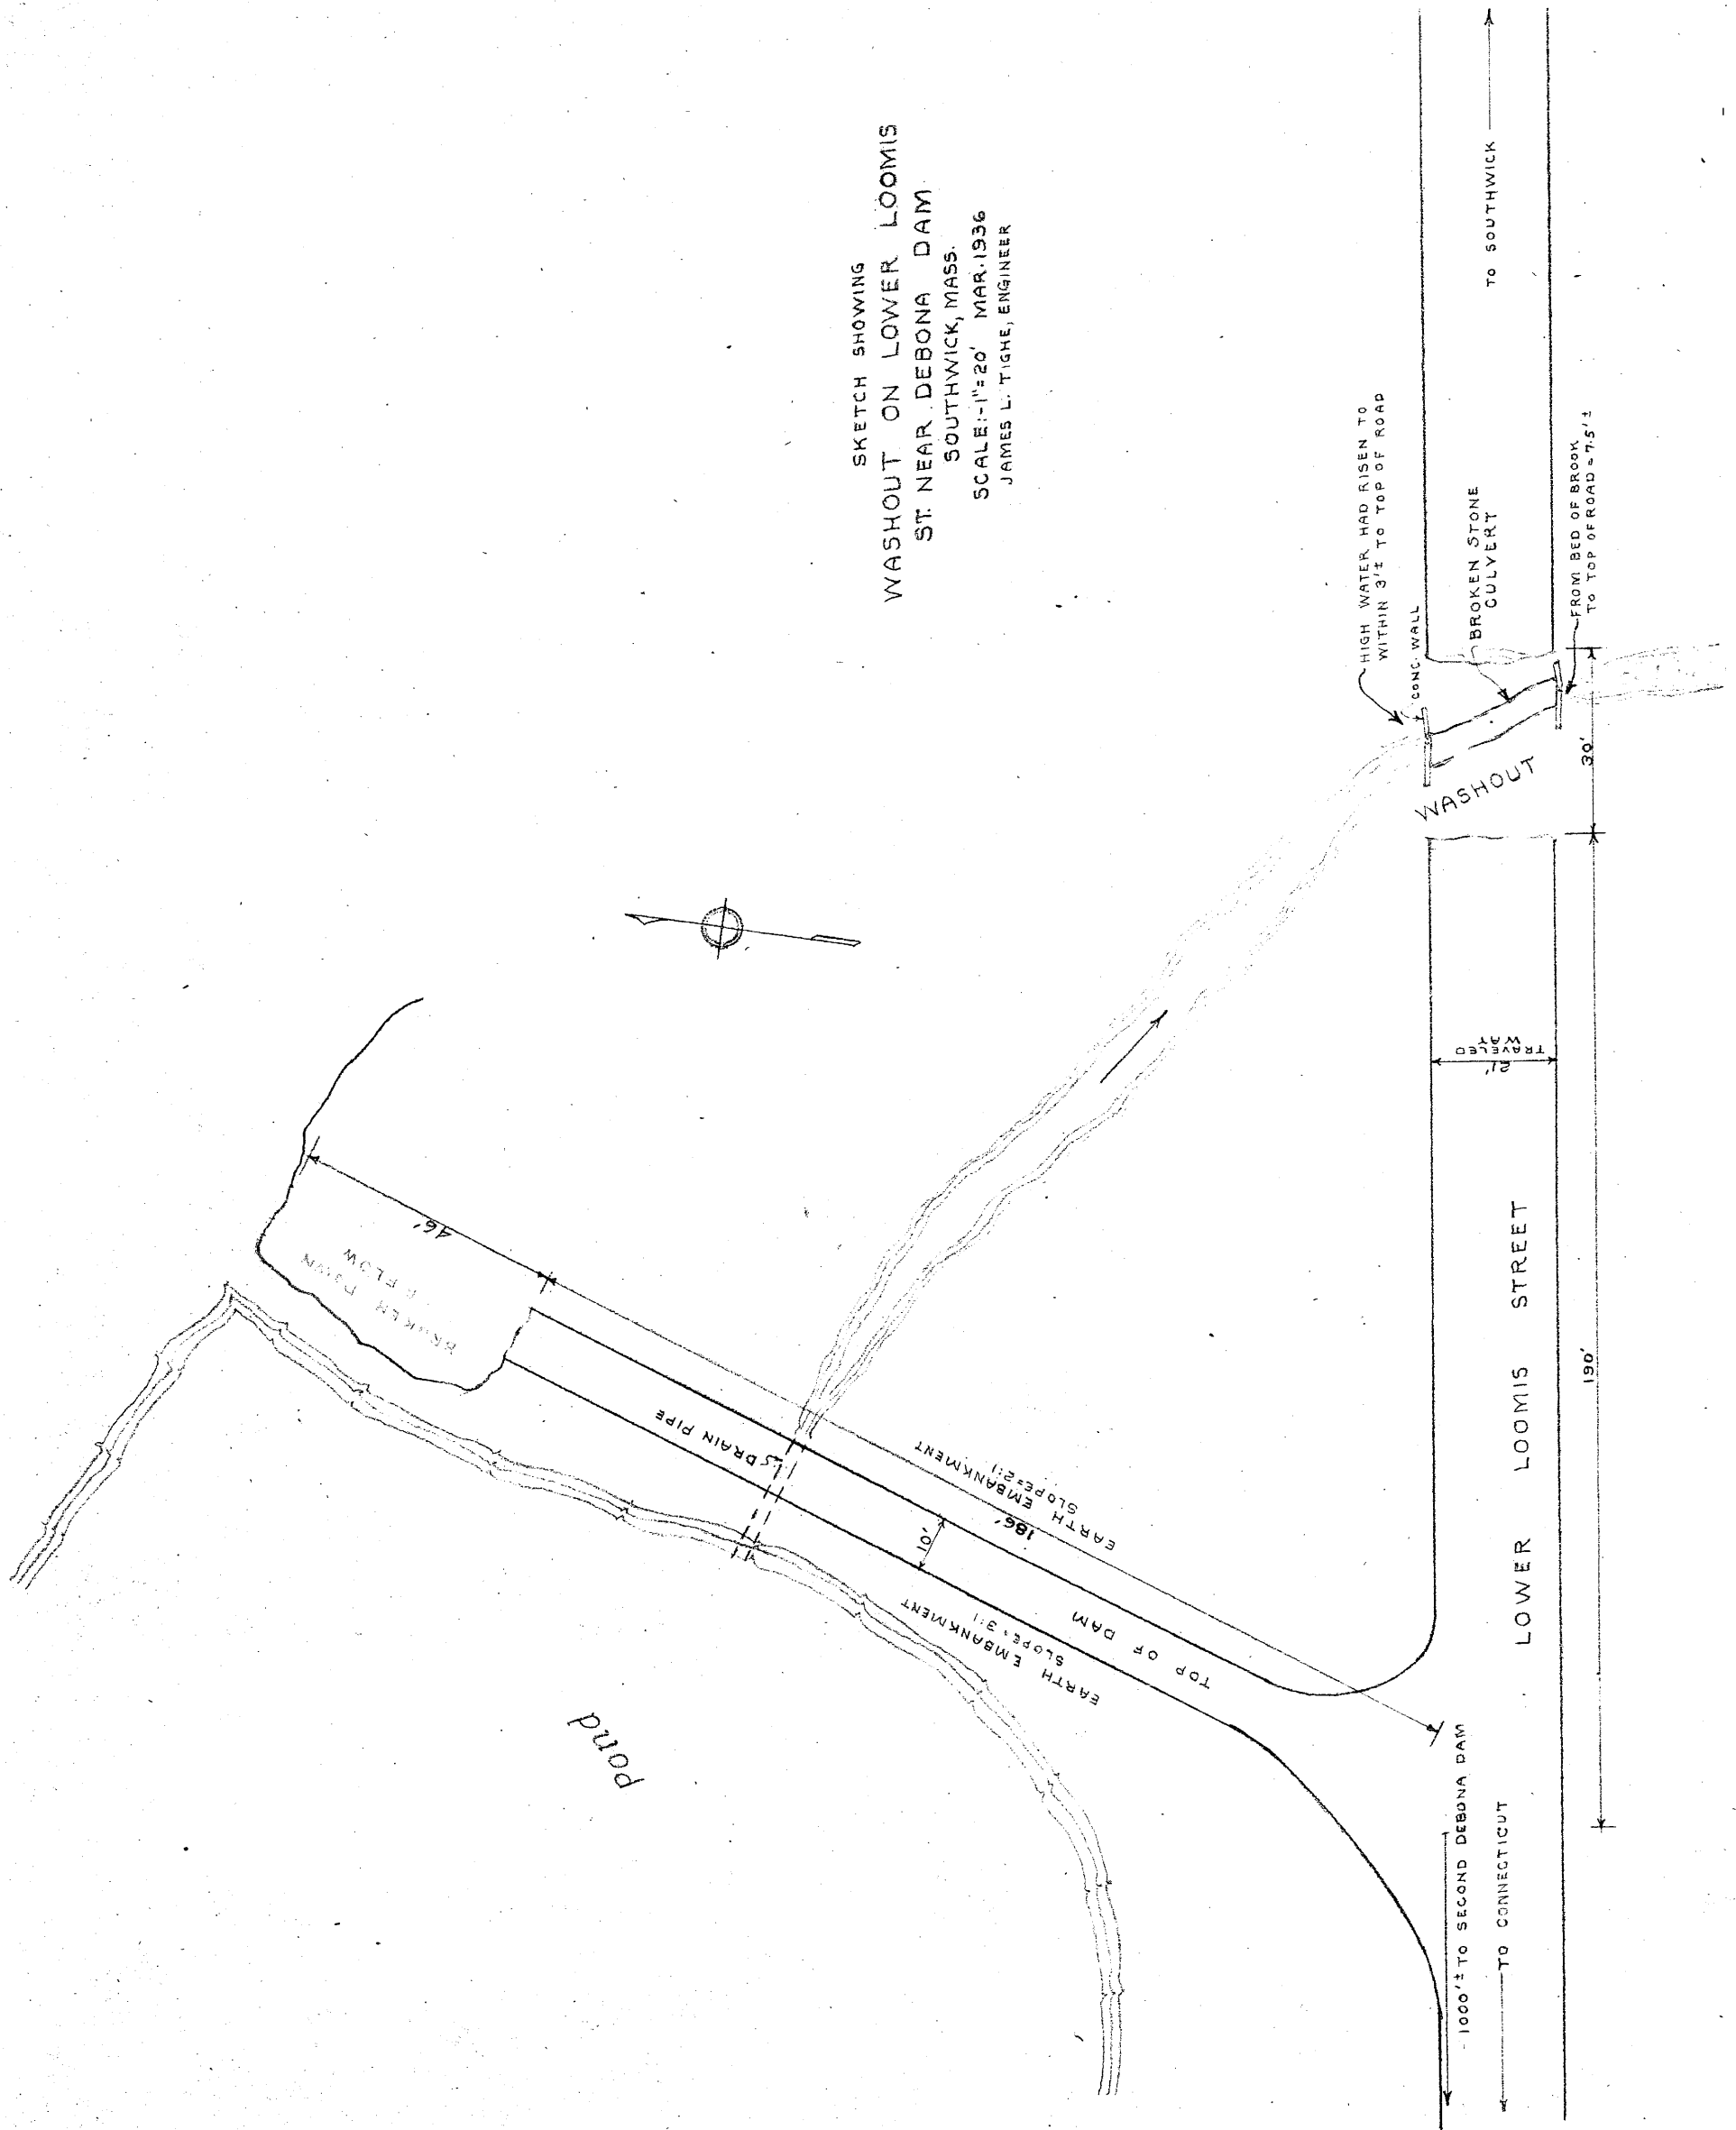
SKETCH SHOWING  
WASHOUT ON LOWER LOOMIS  
ST. NEAR DEBONA DAM  
SOUTHWICK, MASS.  
SCALE: 1"=20' MAR. 1936  
JAMES L. TIGHE, ENGINEER
